Camber Castle

**A look into the past of
Henry VIII's castle**

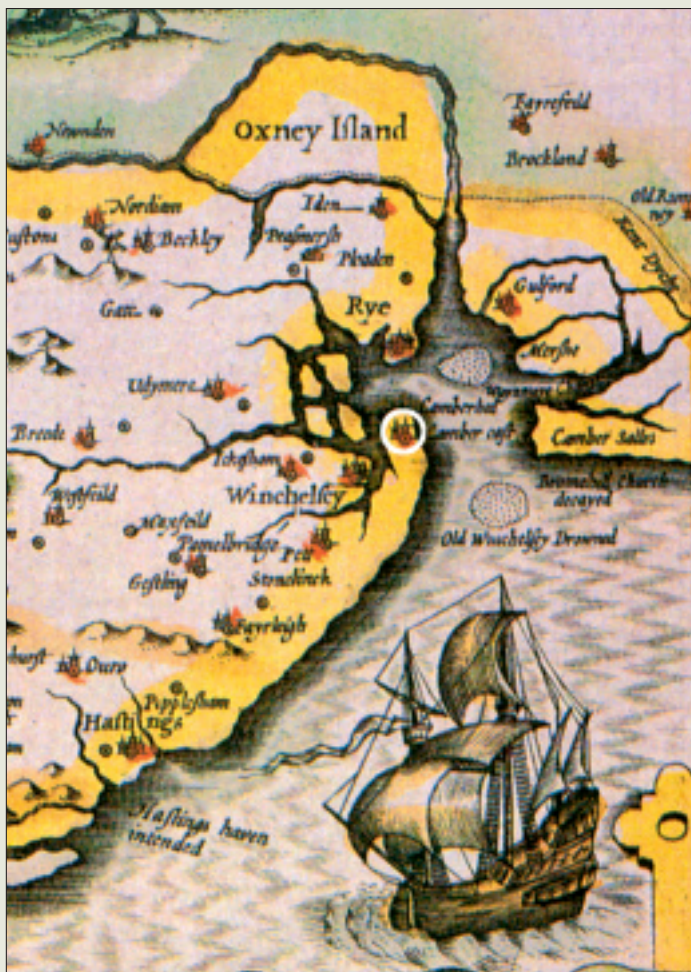
John Speed's map of 1610. Camber Castle is circled.

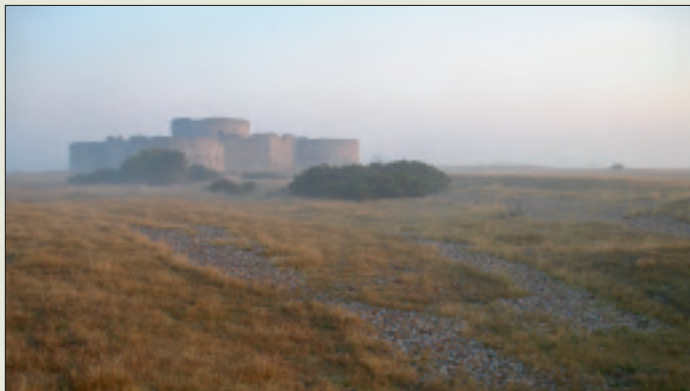
Camber Castle stands on old shingle ridges

Looking out at roof level across the fields to the sea beyond, you can see how the coastline has changed. The ridges in the ground are shingle with a thin layer of soil on top. Each one is where the coastline lay for a short while and shingle accumulated.

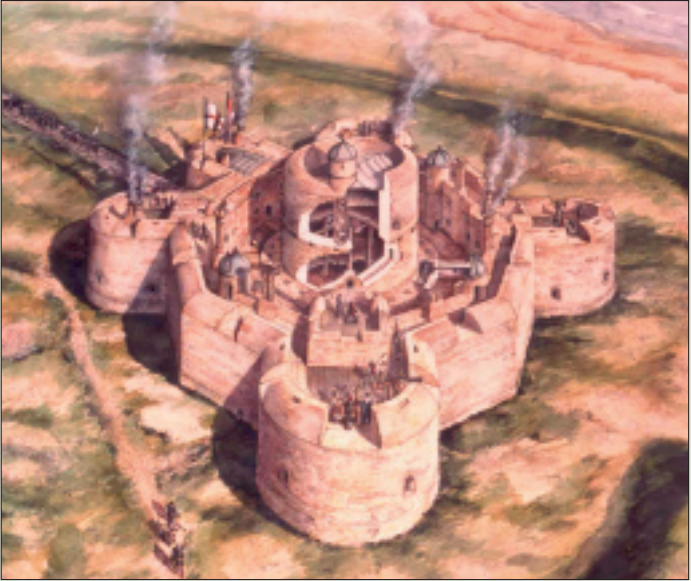
A reconstruction of Camber Castle as it may have appeared in 1540

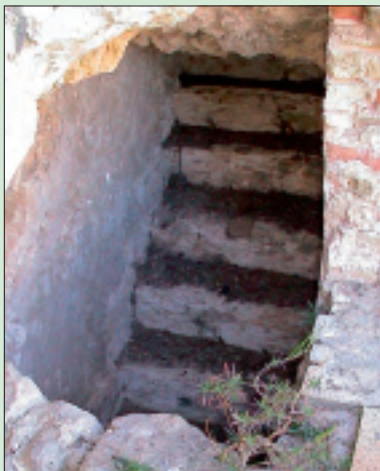
Entrance Bastion

The entrance to the castle is through the gatehouse in the northwest bastion. The gatehouse was built in three stages. First, in Phase II of the construction of the castle (1539-40) a rectangular gatehouse was built. Second, and also in the Phase II works, a D-shaped bastion was added to the front of the gatehouse (forming the curved wall through which visitors enter the castle). Third, in Phase III (1542-43) a first floor was added to the gatehouse and bastion. The rooms on the first floor of the entrance bastion were accessible via stairs in the Inner South Room. There was a private garderobe attached to a suite of accommodation used by the captain, with a room with large windows suitable for entertaining.

Below the entrance was a basement room, but due to the high groundwater levels, this was often flooded, and was abandoned within three years. The staircases down to the basement are still evident on either side of the entrance.

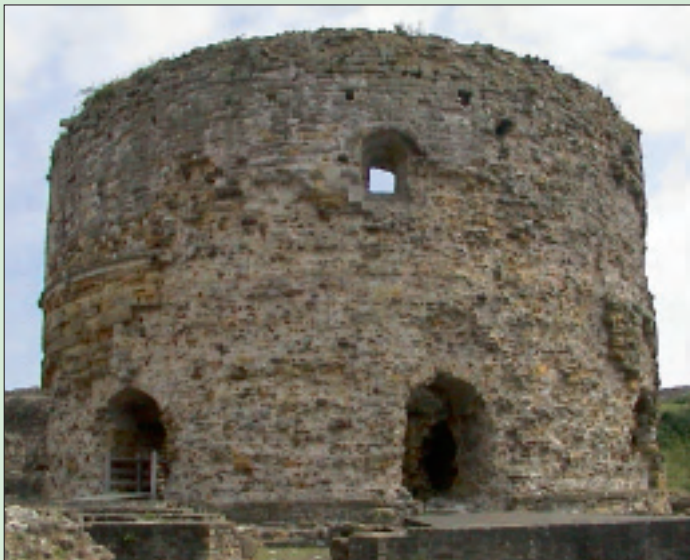
Central Tower

The tower is some 65ft in diameter externally. The 11ft thick walls contained staircases connecting the storeys. The original tower (1512) was about half the present height, and the floor was higher. There were 10 gun ports, a fireplace, and a staircase leading to the roof.

When the tower was raised by Henry VIII the floor was lowered to create a basement level. Above this, extra storeys were added to make three levels, plus the roof. Opposite the viewpoint and at the top of the tower the remains of a circular staircase which led to the roof are still visible.

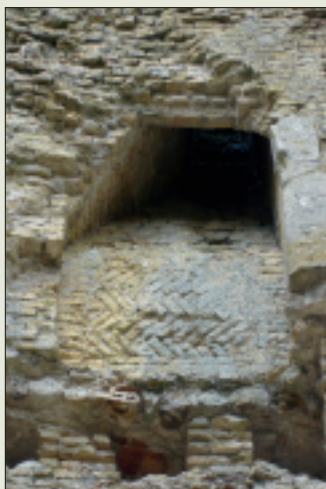
Fireplace showing herring bone brick pattern

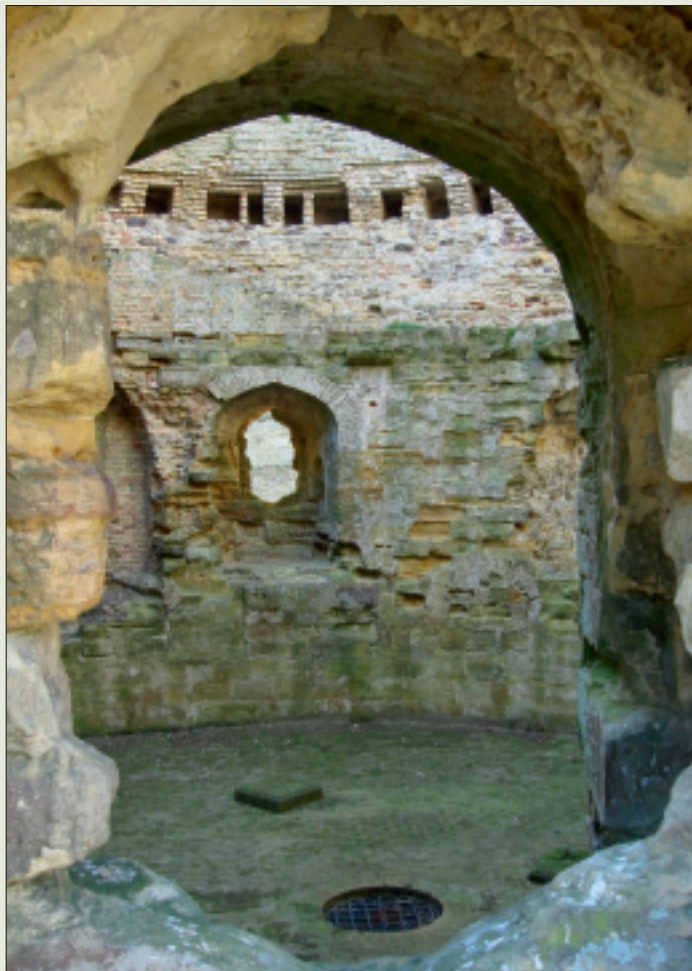
Looking down into the tower, the only remaining floor level is the basement, with a well in the centre. There are also four square stone bases, on which wooden pillars stood to support the upper floors.

Inside central tower showing the well, square stone base and recesses for beams

Around the circumference of the tower there are recesses at the height of each level.

These would have held the beams to support the floors, but are now used as nest sites by a variety of birds.

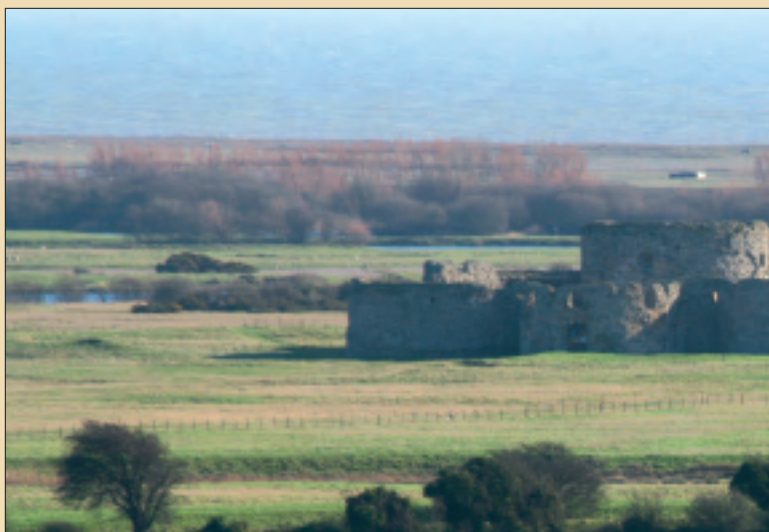
The straight wall submerged in the earth of this bastion is the remains of the Stirrup Tower. It is the top part of the straight chord wall (the stirrup towers were D-shaped, the curve facing inwards towards the central tower).

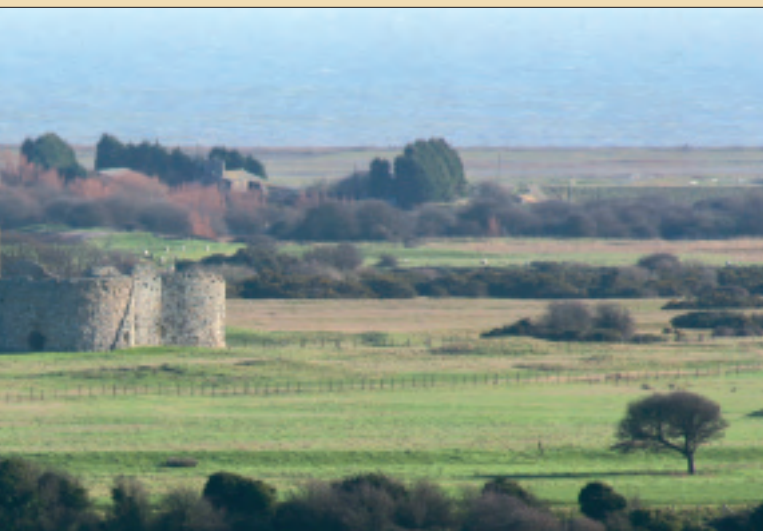
The castle now lies 1700m from the shore

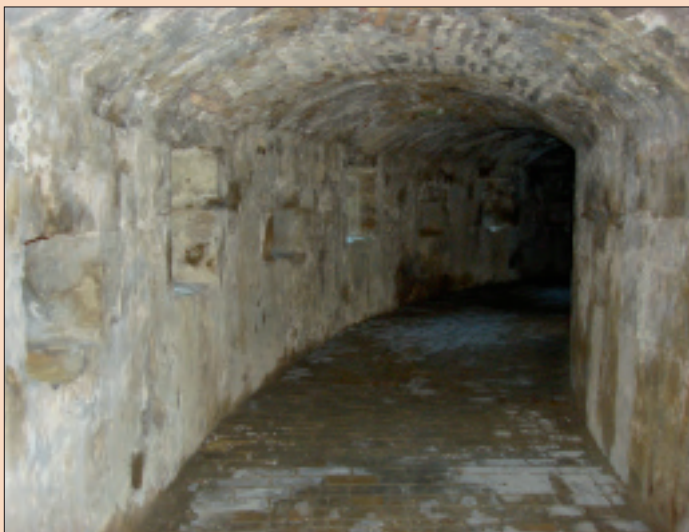
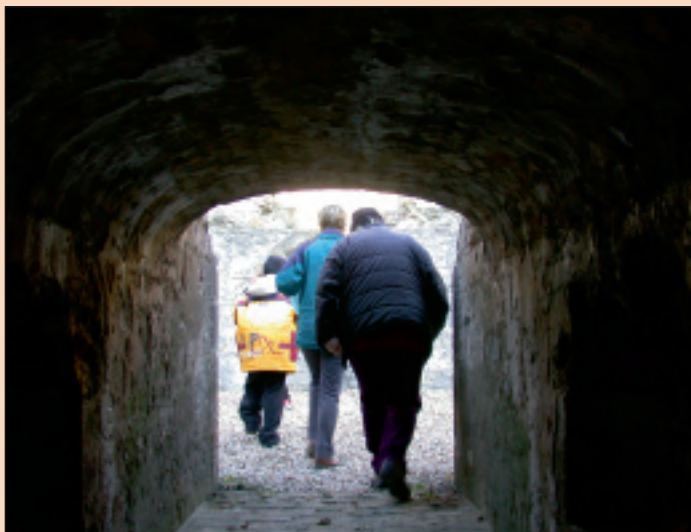
Vaulted Passageway

There is a circular vaulted passage which runs around the base of the central tower. The roof has partly fallen in, but originally the full length was covered. Walking along the passageway, the 'loop-lights' which let light in, would have enabled the soldiers to defend the central tower if the outer walls had been breached and the enemy were in the courtyard above.

Between each loop-light there is a rectangular niche in the wall for general storage. There are two arched doorways leading into the basement level of the central

tower, and four radial passages leading away towards the four bastions (only two of these passages are now accessible). The radial passages are significantly lower than the vaulted passageway. Even though the average height of people was less than it is today, the passages were built lower for a reason. If the outer walls were breached by the enemy, the only way into the tower was via these radial passages – the enemy would have to duck to enter the passage, thus making it harder for them to attack.

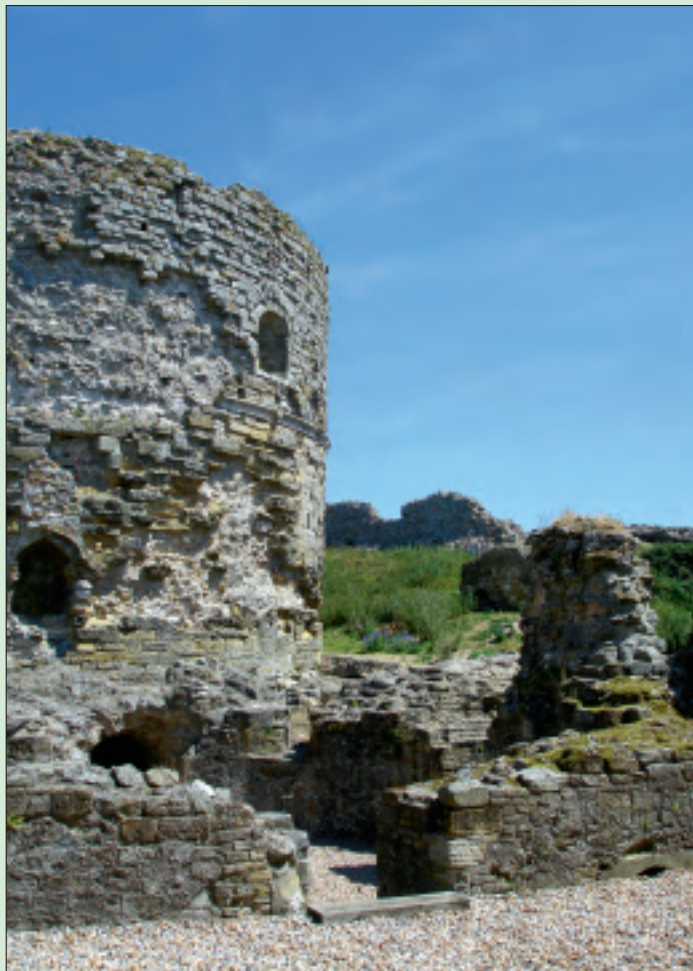
*Looking from Kitchen Bastion to Central Tower
with derelict Stirrup Tower between*

The stirrup towers are D-shaped towers which had two storeys and a parapet at roof level. They stand to the rear of the outer bastions and were constructed during Phase II (1539-40) and were heightened in Phase III (1542-43). 'Gunloops' provided cover for the courtyard, in case the enemy made it through the outer walls.

There were four stirrup towers constructed inside the outer bastions. There were rectangular storage compartments in the back wall, either side of the door leading to the outer bastion.

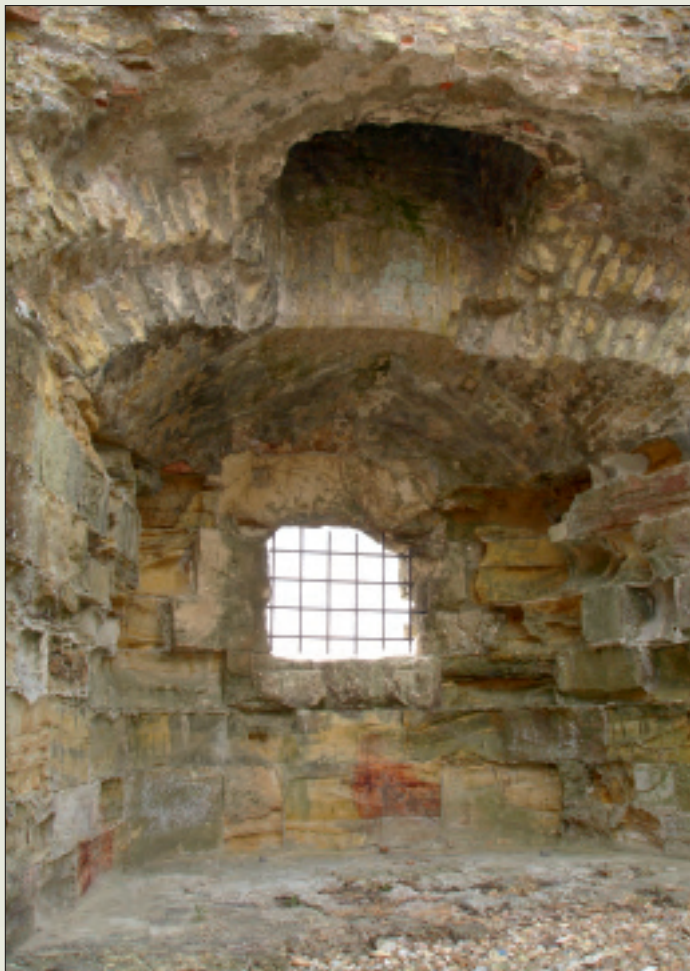
Embrasure showing chimney flue

Above each embrasure there is a chimney flue to allow smoke from the firing of cannon to escape – remember that the bastions would originally have been roofed. With the number of embrasures in each bastion, it would have been possible to create a wide arc of fire, protecting the castle from all angles.

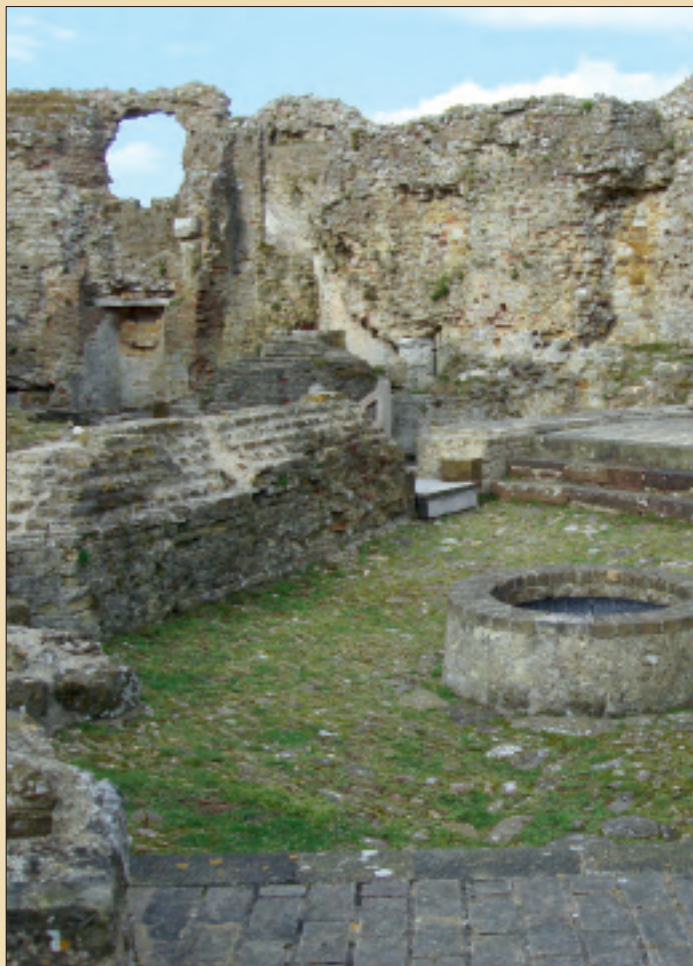
Courtyard showing well

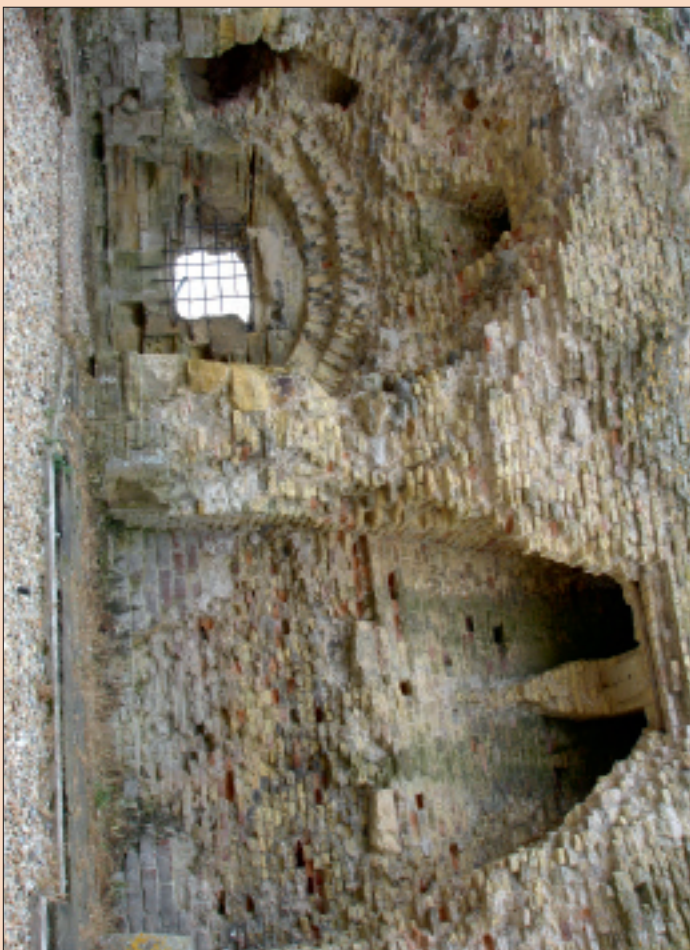
Right to left, the double chimney, the chimney flue above the embrasure, the bread oven

The outer bastion situated on the west of the castle was used as a kitchen by the garrison. There is one main fireplace in the side wall where the majority of the cooking would have been done. It possesses a double chimney and would have had an iron cooking range at its base.

At both ends of the semi-circular walls there are bread ovens. These are lined with tiles to withstand the heat, and each has a small chimney connected to it.

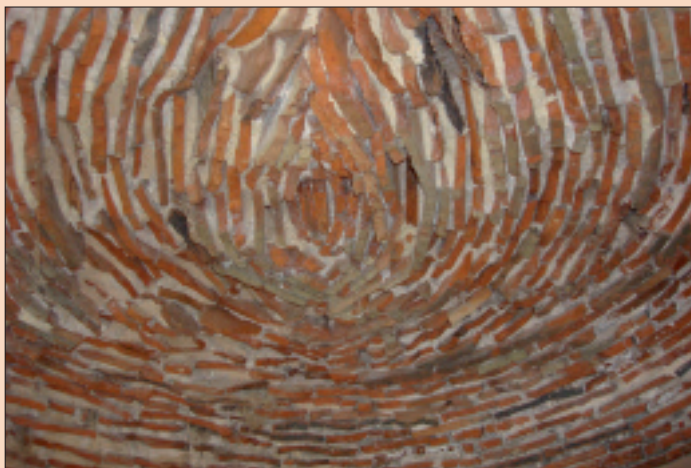
Tiled interior of bread oven

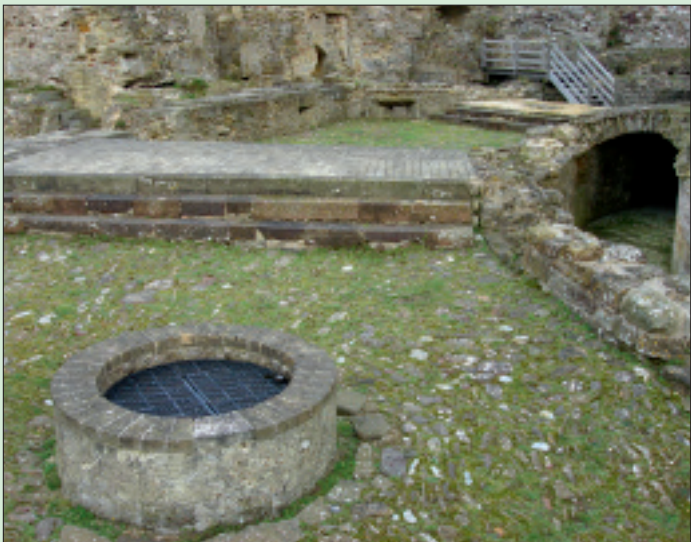
Well in the courtyard

The well in the courtyard is one of two supplies of water in the castle (there is another in the tower). Although the top of the well has been rebuilt, the interior walls are original.

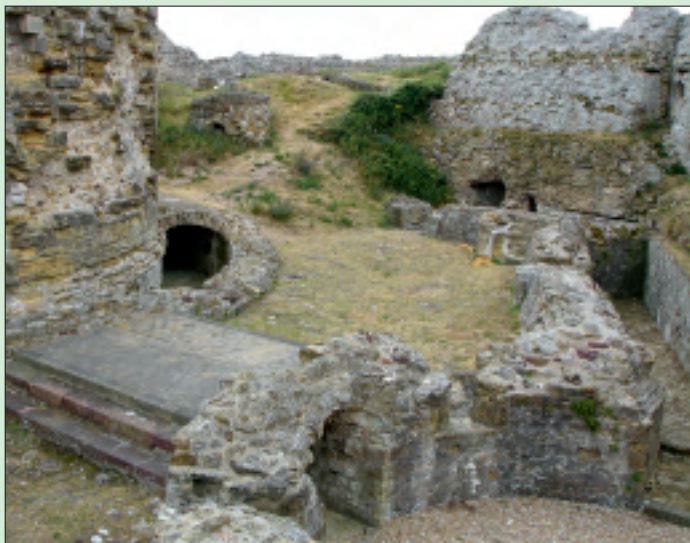
Courtyard showing steps over the radial passages and Stirrup Tower bottom right

On either side of the courtyard there were covered passageways ringing the castle. Next to the tower was the Vaulted Passageway (partially fallen in now), and on the outward side was the Mural Passage. Both are still present, and are connected by radial passages passing beneath the courtyard.

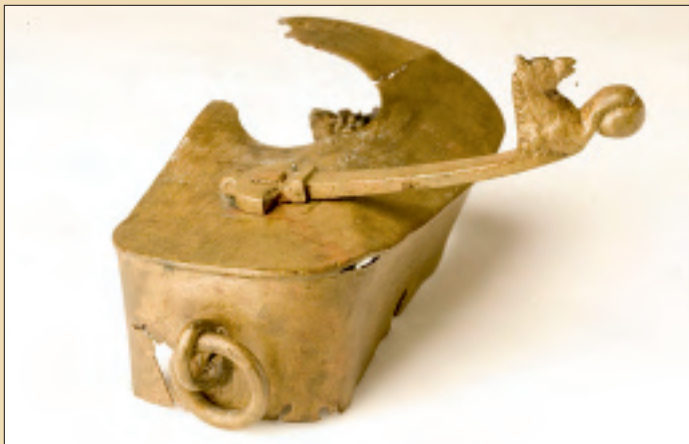
Gunpowder dispenser

Muskets and other handheld guns were also used and stored in the castle. Parts of muskets and musket equipment have been found, including matchlocks, powder flasks, wormer and musket balls.

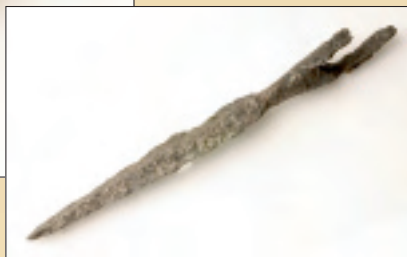
Spear

Examples of hand weapons including four halberds and six pike heads have been excavated, but few sword pieces were found which is surprising at a site of this period.
